# ANNA COVES

## PROPERTY OWNERS ASSOCIATION

### 2026 REPLACEMENT RESERVE STUDY UPDATE

October 2026

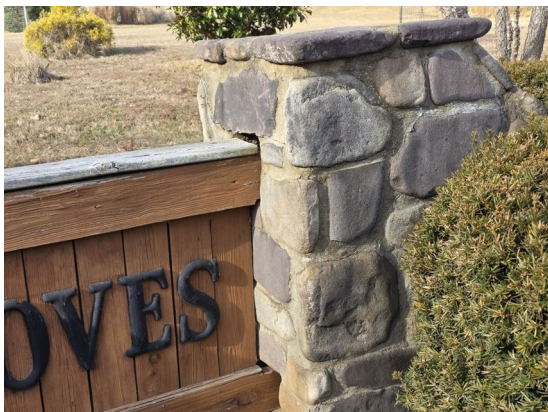
Entrance monument cap — cracked/spalled cap stone, consistent with the overdue repointing item (Item #1)

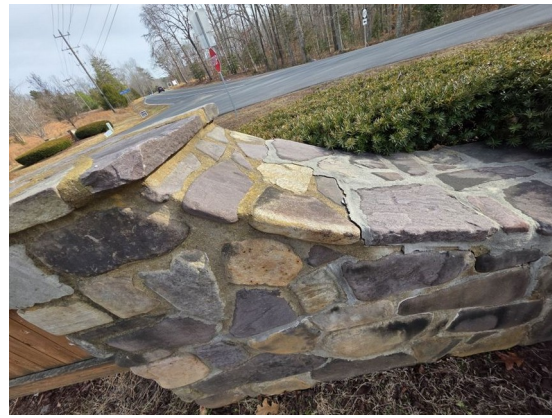
Monument cap — visible cracked/failing mortar joint (Item #1)

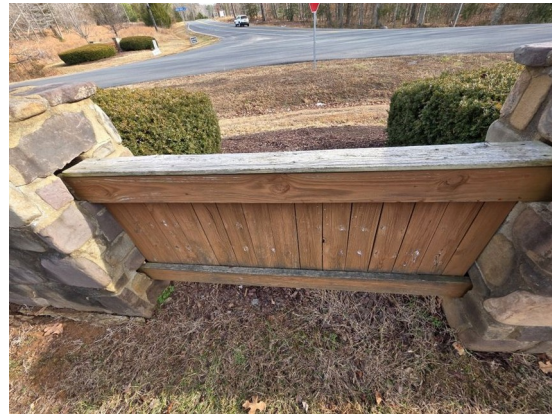
Wood-panel infill, close view — weathering and surface staining visible (Item #2)

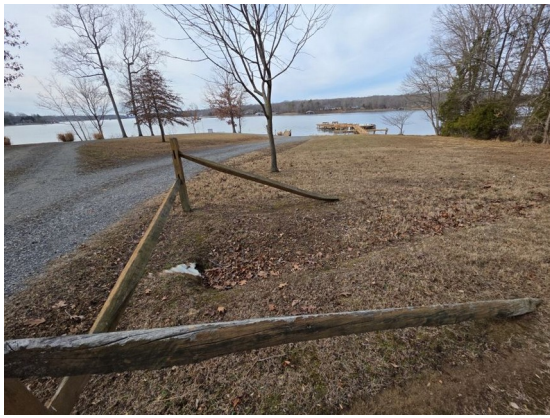
*Gravel drive and split rail fence — fence rail appears loose/leaning  
(Items #4, #7)*

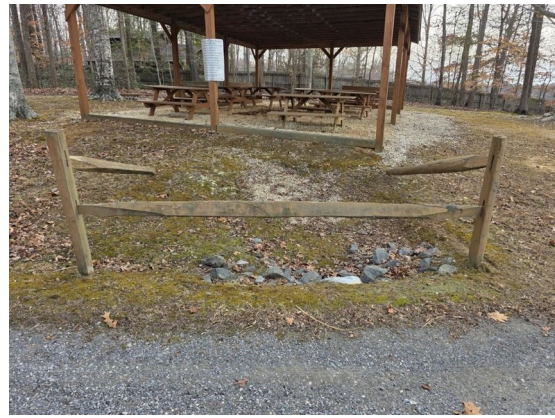
*Split rail fence near the picnic shelter — appears in sound condition  
(Item #7)*

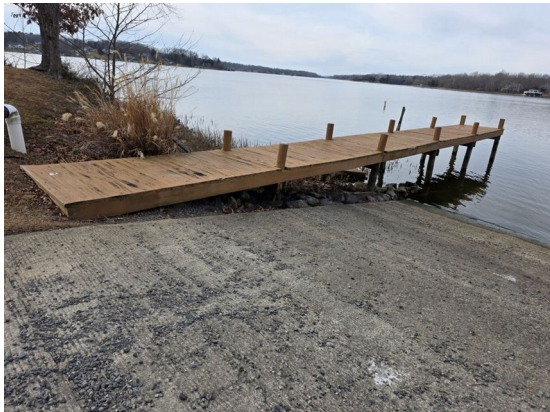
*Boat launch dock and concrete boat ramp, prior to the approved repair  
(Items #17-#19)*

Per the Board's October 17, 2026 meeting, the Board approved a \$13,000 contract with Shoreline Services to reposition the launch dock's poles, install new ledgers and joists, and add new composite decking matching the main slip dock (2010 Items #17-18). Because this work substantially rebuilds both the decking and the supporting structure, it is modeled the same way as the main dock: the actual contract cost is treated as funded from the reserve balance in 2026, and the launch dock's remaining useful life is reset to a full cycle from 2026 (future decking cycle around 2041, full structural cycle around 2056). The Board should confirm this treatment reflects the actual scope of work performed; a more limited repair that leaves the underlying structure on its original timeline would call for a smaller life-cycle reset.

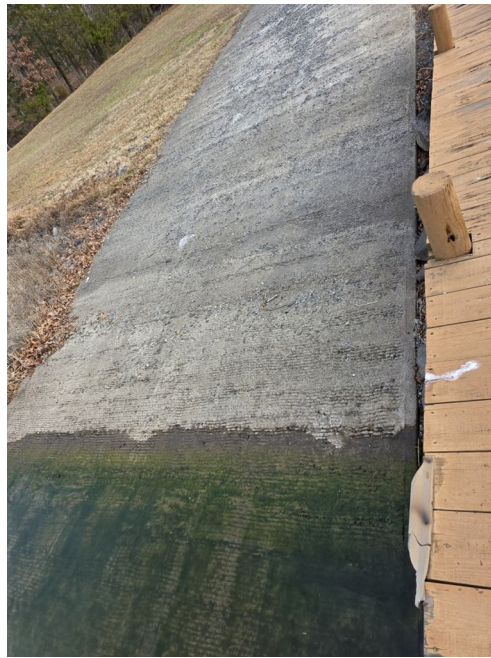
*Concrete boat ramp at the waterline — algae/staining visible on the lower ramp surface (Item #19)*

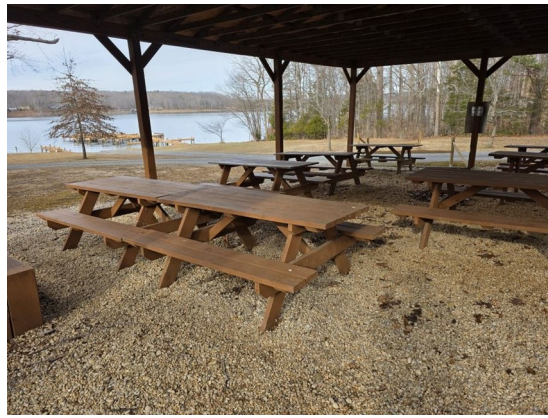
*Picnic tables under the shelter, close view — Association currently has 9 tables (Item #13)*

- The Association currently has 9 picnic tables, matching the 2010 baseline used in this model's cost (\$4,050 in 2010 dollars / \$6,205 in 2026 dollars for 9 tables). The Board should decide whether to replace like-for-like (9 tables) or add a 10th table when this item is next replaced; adding one table would cost roughly \$689 more in 2026 dollars.

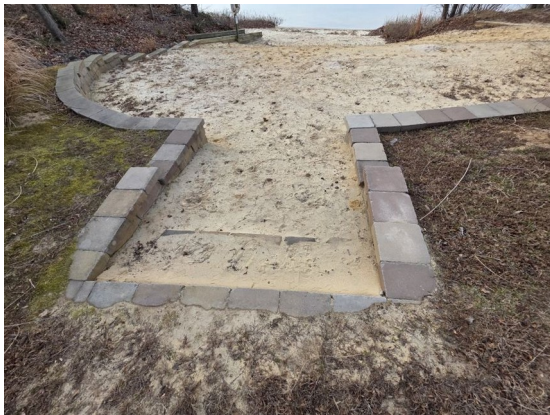
*Sand beach access with paver edging — note pavers now in place of the 2010 wood timber retaining wall (Item #20, formerly Item #8)*
